NASA TN D-7001

ANNULAR SLIT COLLOID THRUSTER RESEARCH AND DEVELOPMENT

by Kenneth W. Stark and William A. Burton

*Goddard Space Flight Center
Greenbelt, Md. 20771*

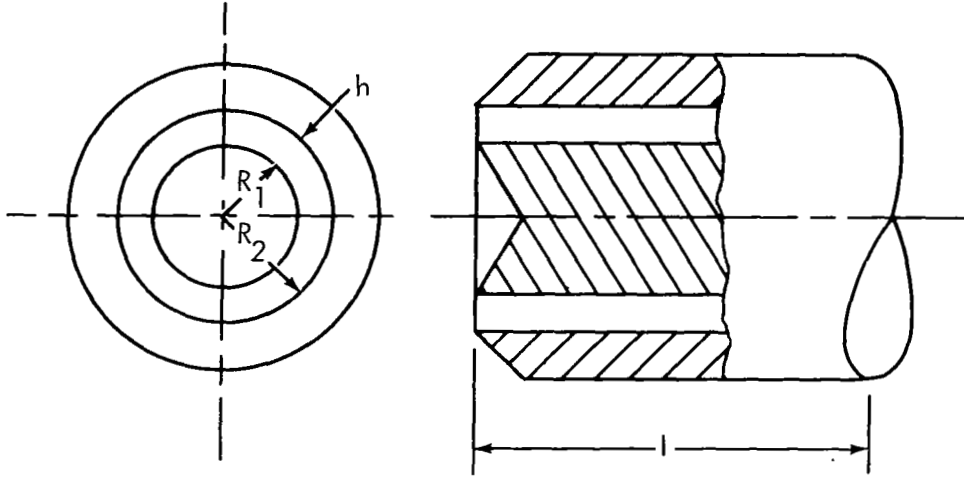
The exact equation for flow through a concentric annulus (Reference 3) (Figure 1) is

Figure 1-Concentric annulus diagram.

However, this equation is awkward to use for thruster design since normally the desired flow rate Q is known and the annular gap $R_2 - R_1$ and radius R_1 are the terms to be determined.

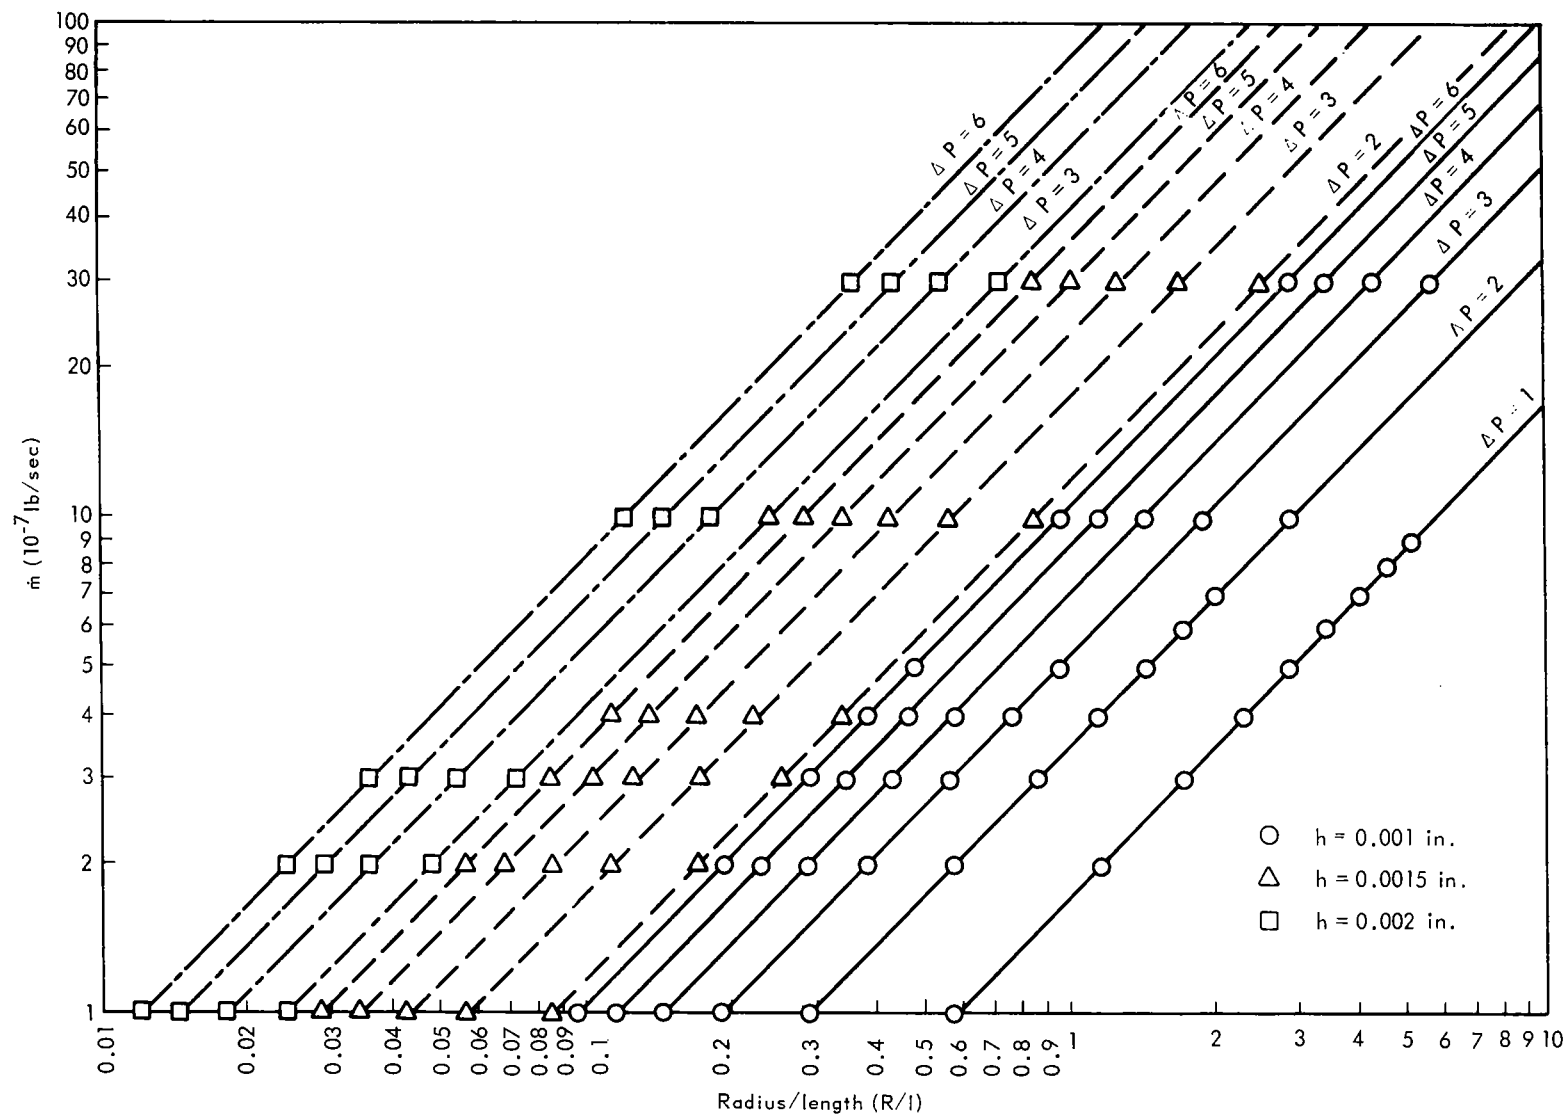
Figure 2— \dot{m} versus R/l for annular slit thruster design. $\dot{m} = \frac{\Delta P \pi R h^3 \rho}{6 \mu l}$, $\mu_{\text{gly}} = 1.383 \times 10^{-7} \text{ lb-sec/in.}^2$, and $\rho_{\text{gly}} = 0.0455 \text{ lb/in.}^3$.

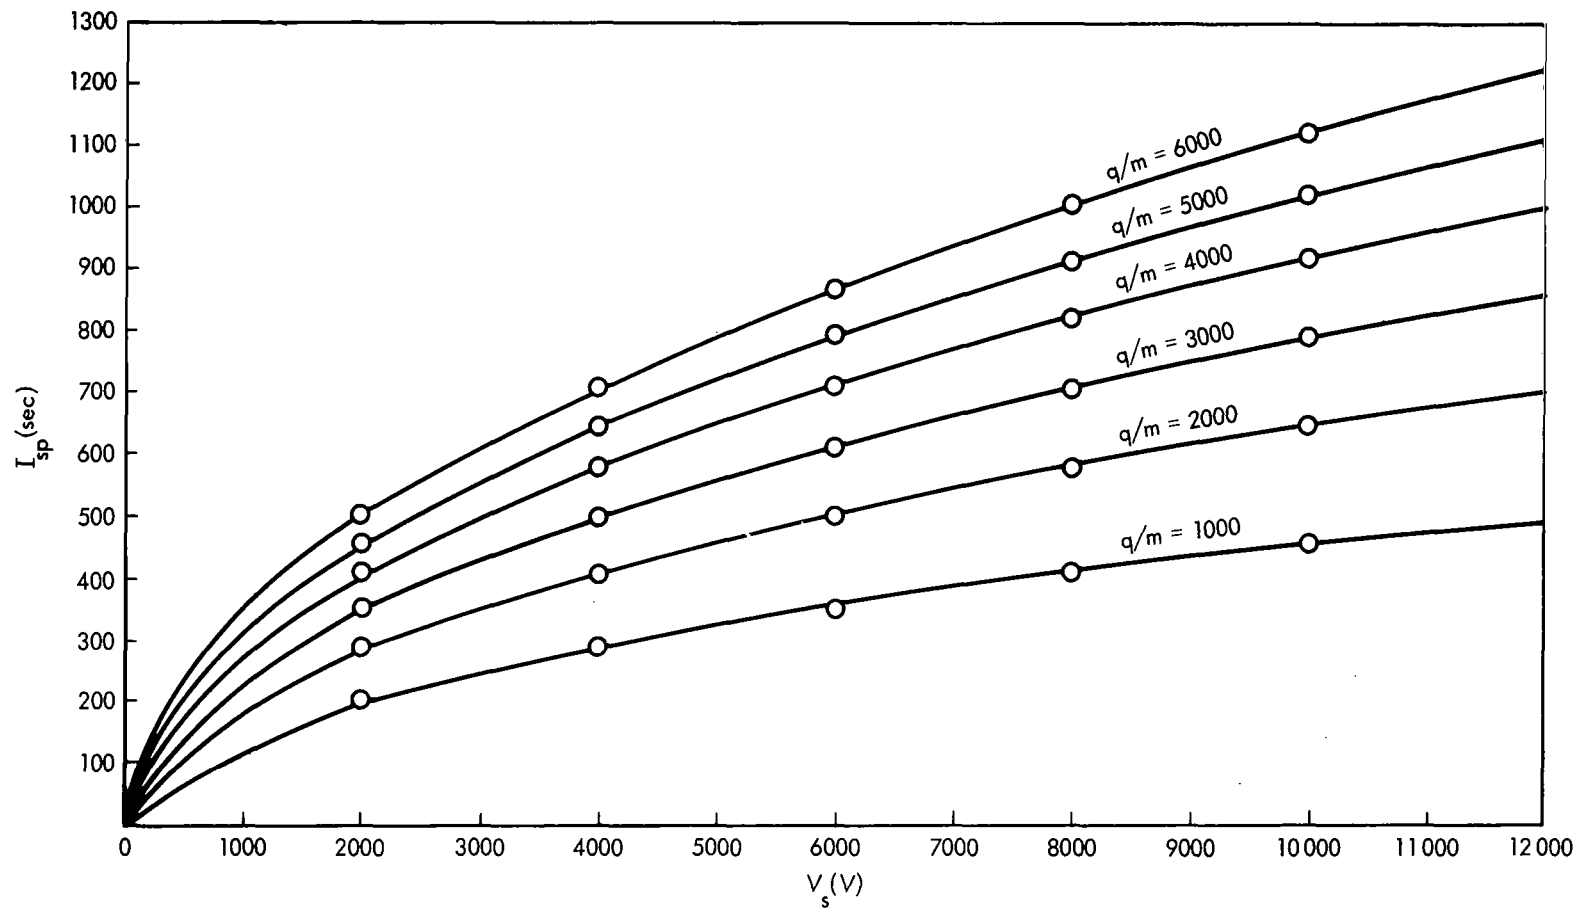
Figure 3— I_{sp} versus source voltage at various q/m 's. $I_{sp} = \frac{4.66}{g_0} \sqrt{q/m \cdot V_s}$, V_s in V, q/m in C/kg, and I_{sp} in sec.

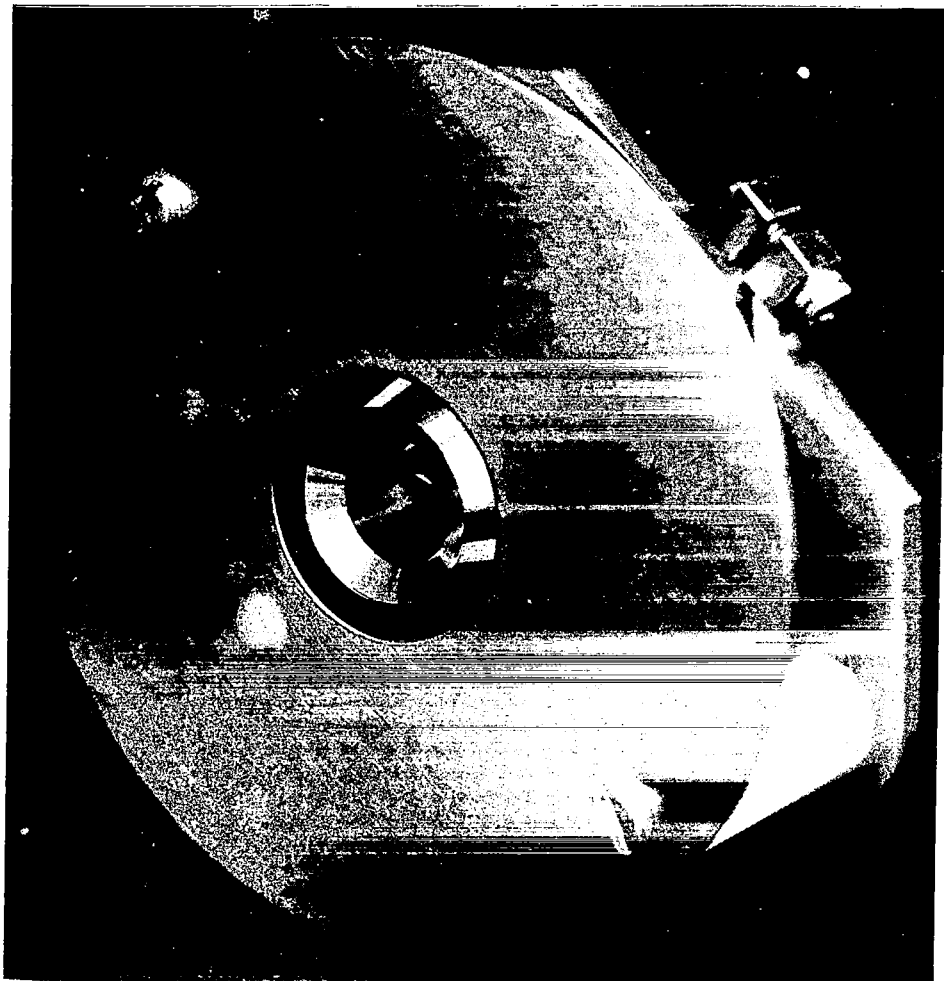
Figure 4—Large annular thruster.

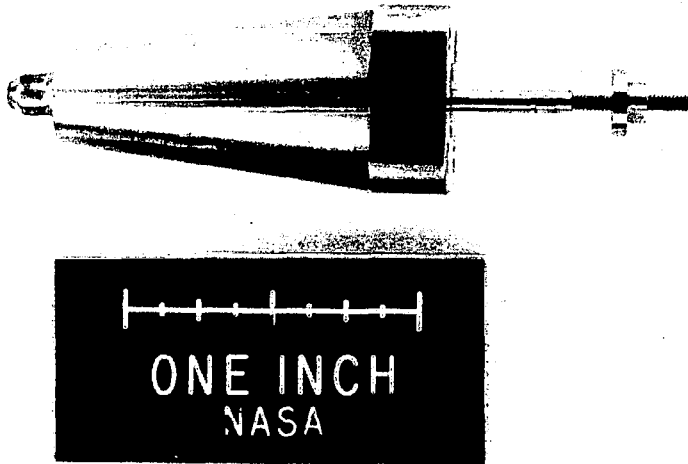
Figure 5—Small annular thruster, (a) side view, and (b) front view.

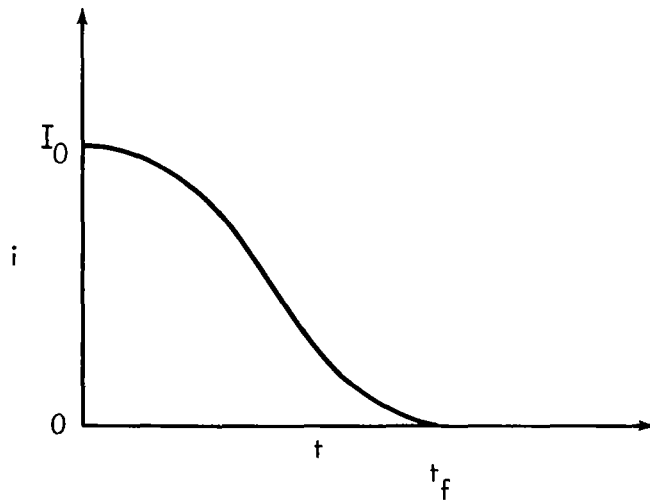
Figure 6—Typical time of flight (TOF) trace.

A TOF trace is obtained by the simultaneous grounding of the thruster voltage and the recording of the collector current decay curve caused by the particles in flight after grounding. A typical TOF curve is shown in Figure 6.

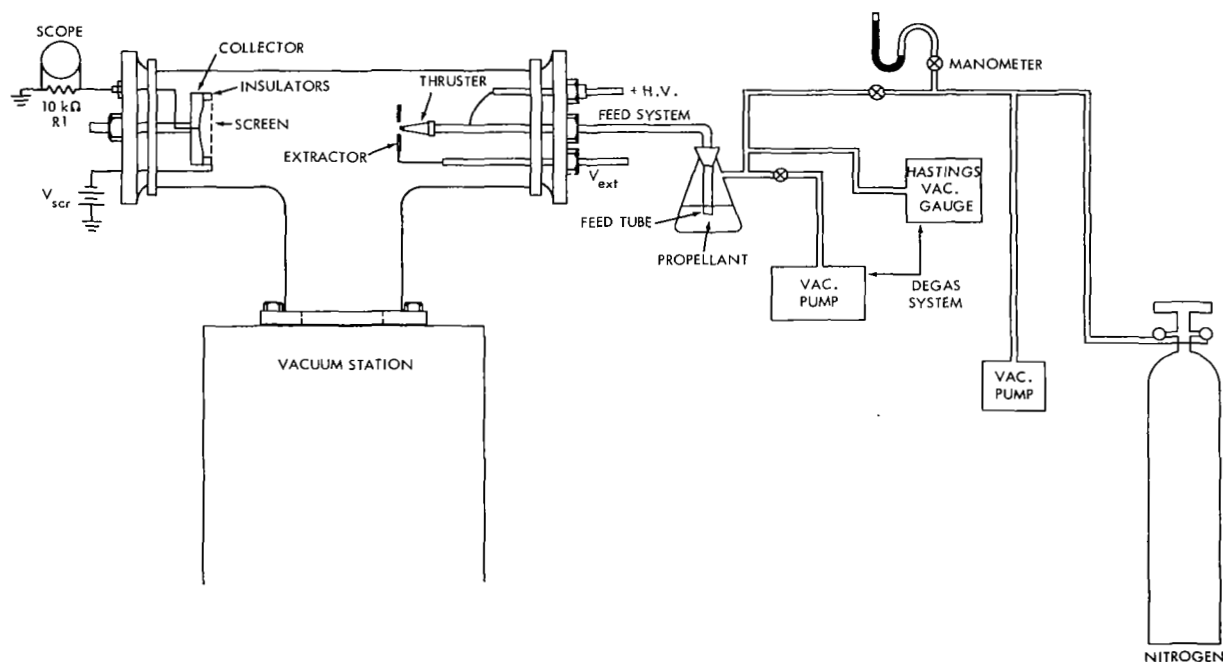
Figure 7—Basic testing apparatus diagram. The collector and the thruster are mounted in a horizontal position.

During the initial series of tests on the annulus thruster, the laboratory test setup was essentially the same as that used with the capillary needles (Reference 2). Figure 7 shows the basic testing apparatus with the collector and thruster mounted in a horizontal position. The feed system shown proved to be satisfactory and was maintained essentially unchanged throughout the annulus testing program.

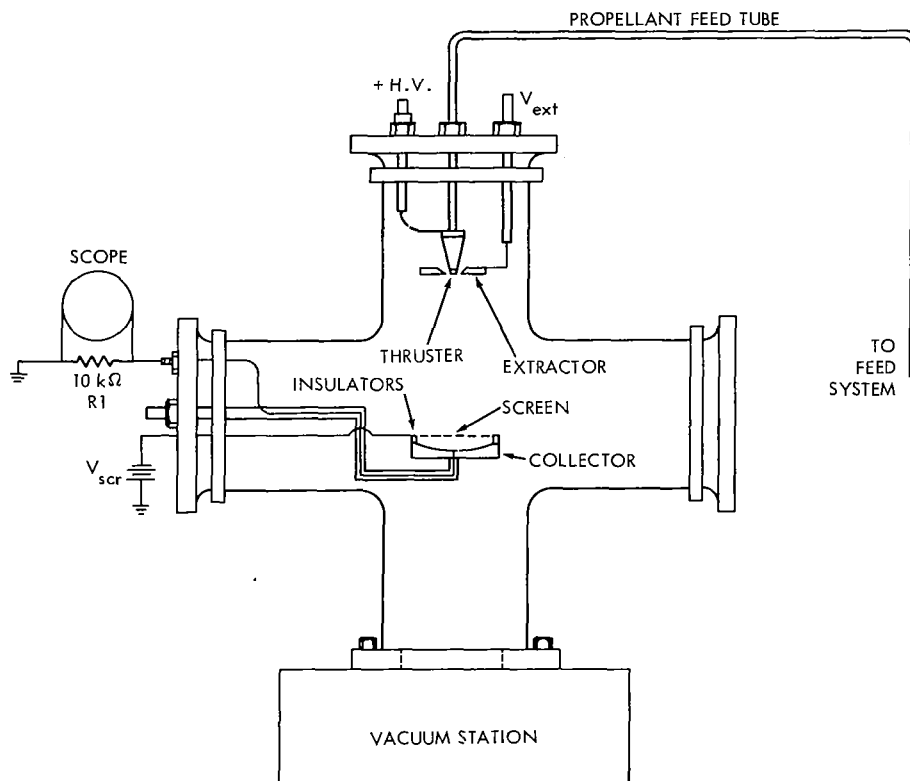
Figure 8—The cross-configuration vacuum chamber. The thruster is mounted in a vertical position.

Figure 8 shows the test setup, a cross configuration vacuum chamber with the thruster mounted pointing downward for a vertical firing orientation. Propellant mixture and voltage parameters were essentially the same as in previous tests.

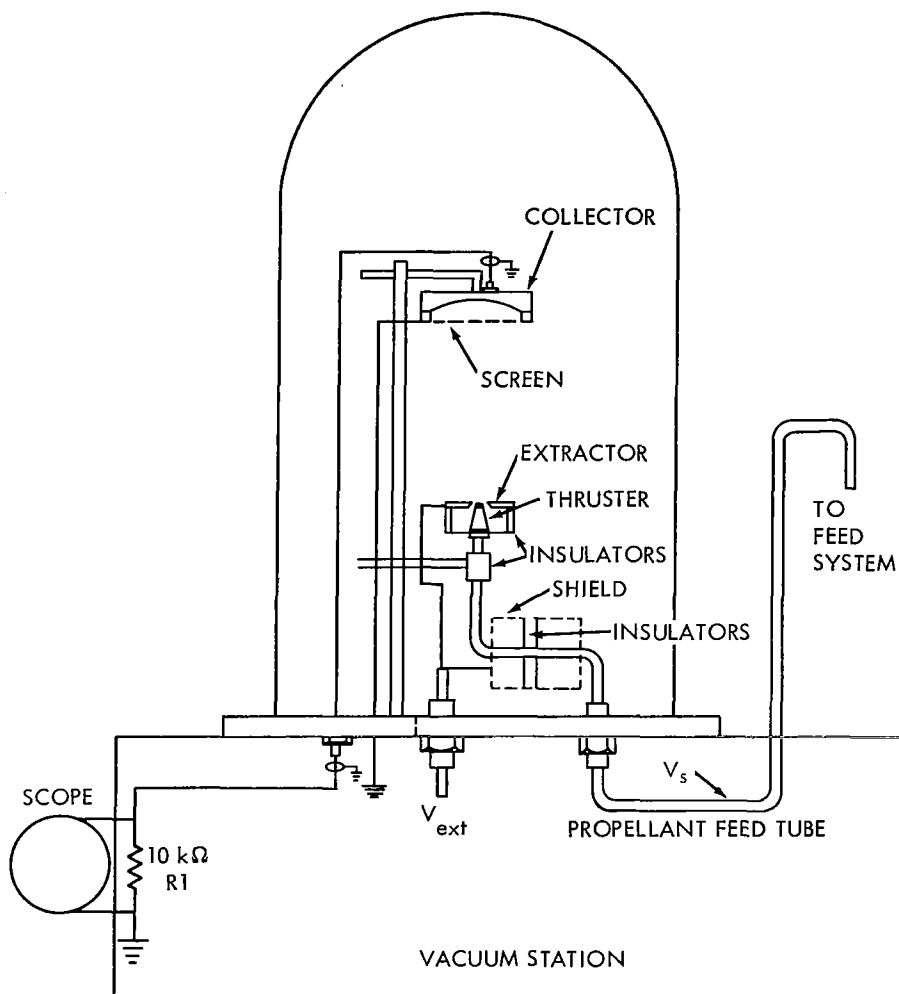
Figure 9—Diagram of the standard bell jar vacuum chamber used to facilitate vertical firing.

A standard bell jar vacuum chamber was used to facilitate vertical firing with the thruster close to the vacuum port (Figure 9). The port was directly below the thruster. Several problems occurred in initial tests with this setup. The portion of the feedline in the chamber that runs parallel with the base plate was bombarded by secondary particles. The bombardment caused localized heating, which affected the propellant viscosity and, in turn, the flow characteristics. This situation was remedied by the installation of a shield for the feedline in this area maintained at the negative extractor potential.

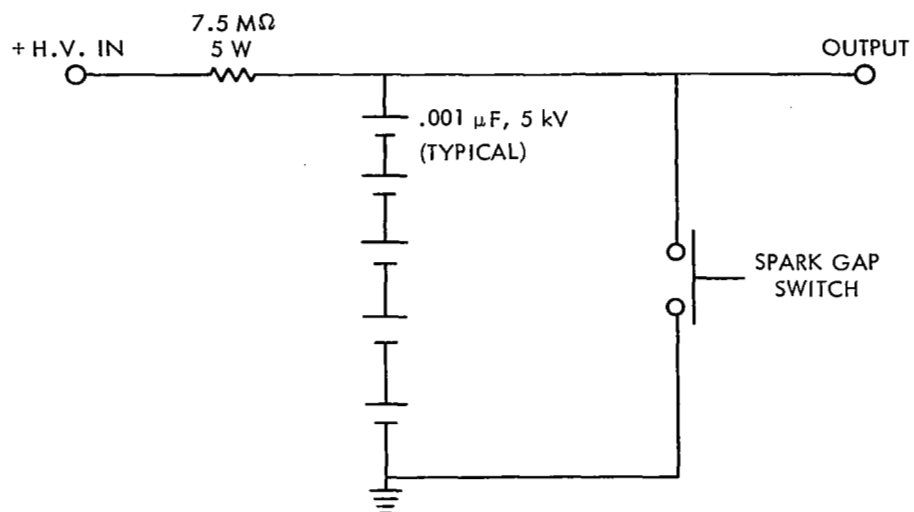
is shown schematically in Figure 10. This is a spring-loaded push rod type of mechanical switch that uses stainless steel balls as shorting contacts. Load resistors were incorporated to prevent the high-voltage power supply from being overloaded during shorting. This unit operated satisfactorily as long as collector currents were of a high enough level to maintain oscilloscope input sensitivity at 10 mV/cm or lower. Characteristic TOF "dead times" under these conditions were 7 to 12 μ sec (Figure 11) with a trigger transient apparent. Dead time is defined as the period between shorting the thruster voltage to ground and the beginning of the TOF current decay curve. As oscilloscope input sensitivity was increased above 10 mV/cm, the trigger transient saturated the preamplifier and caused the dead time to increase. Collector currents at this time were of sufficient magnitude to enable the oscilloscope input sensitivity to be maintained at the lower levels. However, in subsequent testing these levels decreased, and it was necessary to devise a more efficient zapping method.

Figure 10—Ball zapper circuit.

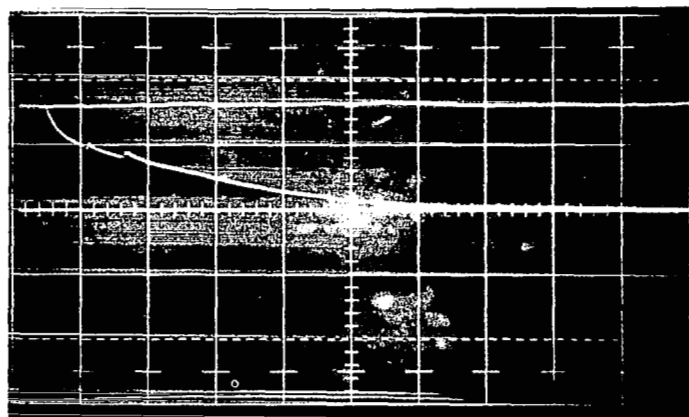
Figure 11—TOF trace of AS-48-2. $V_s = 21.5 \text{ kV}$, $I_s = 140 \text{ μA}$, $i = 10 \text{ μA/cm}$, and the sweep was 20 μsec/cm .

AS-48 was the next test conducted and used propellant No. 5. V_s had to be set at 21.5 kV to obtain stable performance. As shown in Table 3, performance was still low. After 1 hour, glow spray commenced and the test was terminated. As in AS-46, the thruster was very hot. Examination of the thruster after the test showed severe rim erosion (Figure 45). The TOF trace is shown in Figure 11.

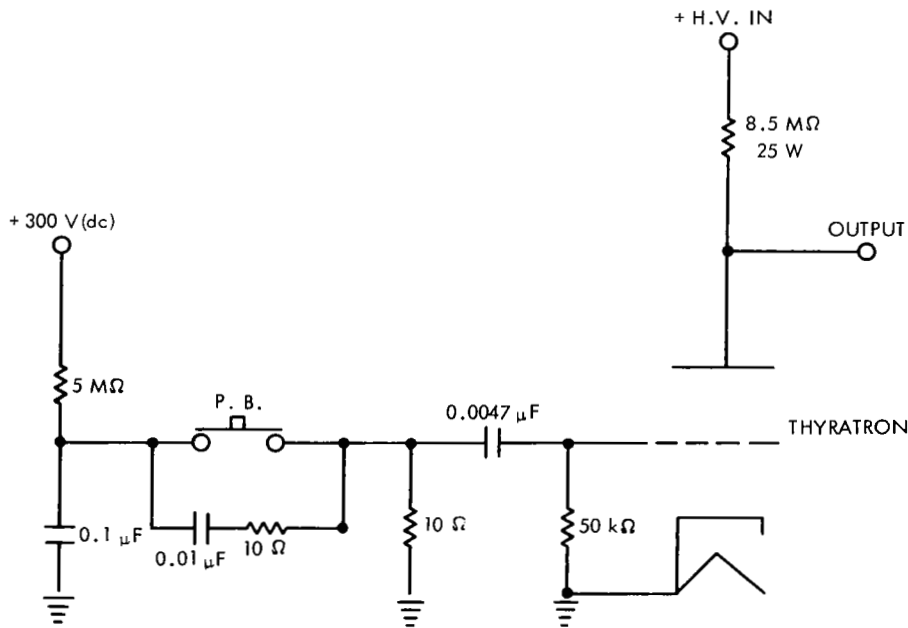
Figure 12 is a schematic diagram of the final version of the thyratron zapper unit used in the latter stages of testing. Operation of this unit depends on short circuiting the high voltage to ground through the thyratron by biasing the control grid to start conduction. This method of operation eliminates the arcing and consequent radiation associated with the shorting of the high voltage through a mechanical switching device. Essentially, this eliminated the transient effects of the ball zapper previously used, and consequently collector current amplitude ceased to be a major factor in dead time variations. Testing conducted with this zapper unit resulted in TOF traces with dead times of 5 to 10 μsec . Redesign of the collector configuration to permit the collector to be completely surrounded by a grounded shield resulted in further reduction of this dead time to 3 to 5 μsec (Figure 13). The final version of the collector configuration is shown in Figure 14.

Figure 12—Thyratron zapper circuit.

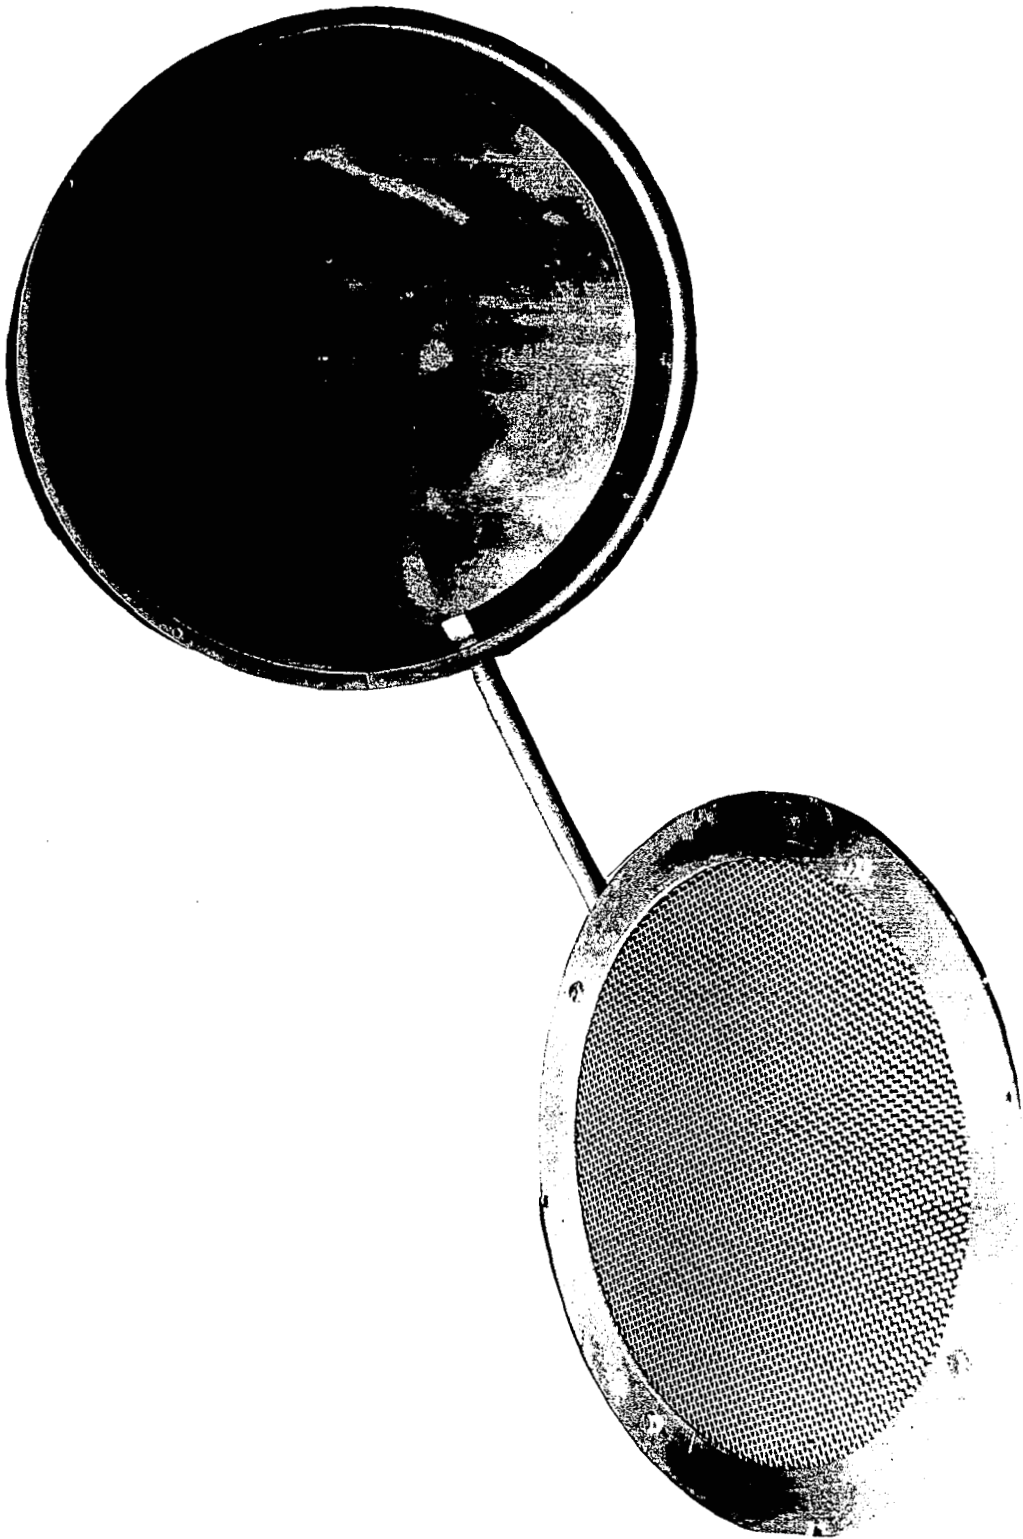
Figure 14—Stainless steel shielded collector assembly.

As mentioned in the test section of this report, several changes were made in the test apparatus before testing the large thruster. A stainless steel collector completely surrounded by a grounded screen (Figure 14) replaced the melamine one, and a thyratron zapper circuit replaced the steel ball zapper.

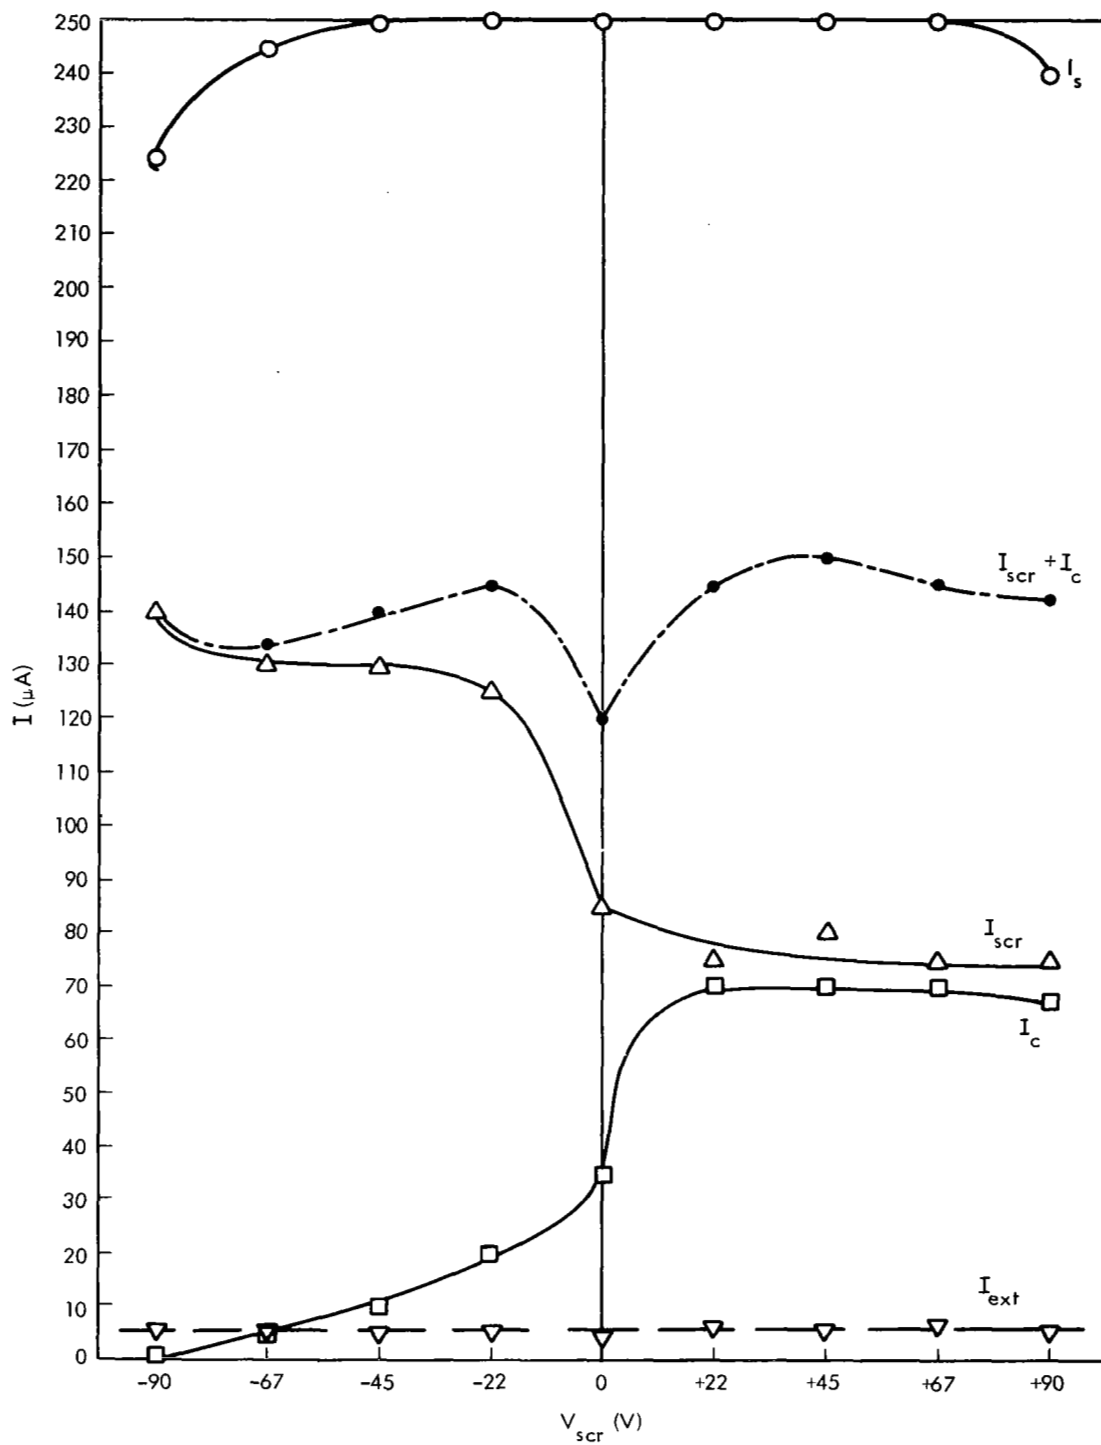
Figure 15—Current variations versus V_{scr} for AS-30 at $V_s = 16.250$ V.

Test AS-30 was conducted to determine the effect of positive V_{scr} on performance. Figures 15 and 16 are plots of current variations as V_{scr} is varied from -90 V to +90 V for source voltages of 16.25 kV and 17.75 kV. In both figures, as V_{scr} approaches -90 V, I_C goes to zero or negative current. When TOF traces were attempted in this regime, excessive noise made acceptable TOF traces impossible. However, as V_{scr} was varied between ground and +90 V, I_C remained constant. In both figures the sum of I_{scr} and I_C varies approximately 20% of its maximum value from -90 V to +90 V of V_{scr} . However, the difference between $I_{scr} + I_C$ taken at V_{scr} of +45 V and -45 V was 7% in figure 15 and 2% in Figure 16. At these points, the comparison TOF traces were taken. In both figures I_S drops off at each extreme of the V_{scr} variation. A possible explanation for this is that in the -45 V to -90 V V_{scr} range, the number of electrons that normally would leave the screen and collector to impact on the positive feed-line and thruster is reduced. Also, in the +67 V to +90 V V_{scr} range, it is possible that some of the positive charges are repelled to the feed system, which causes a slight current reduction.

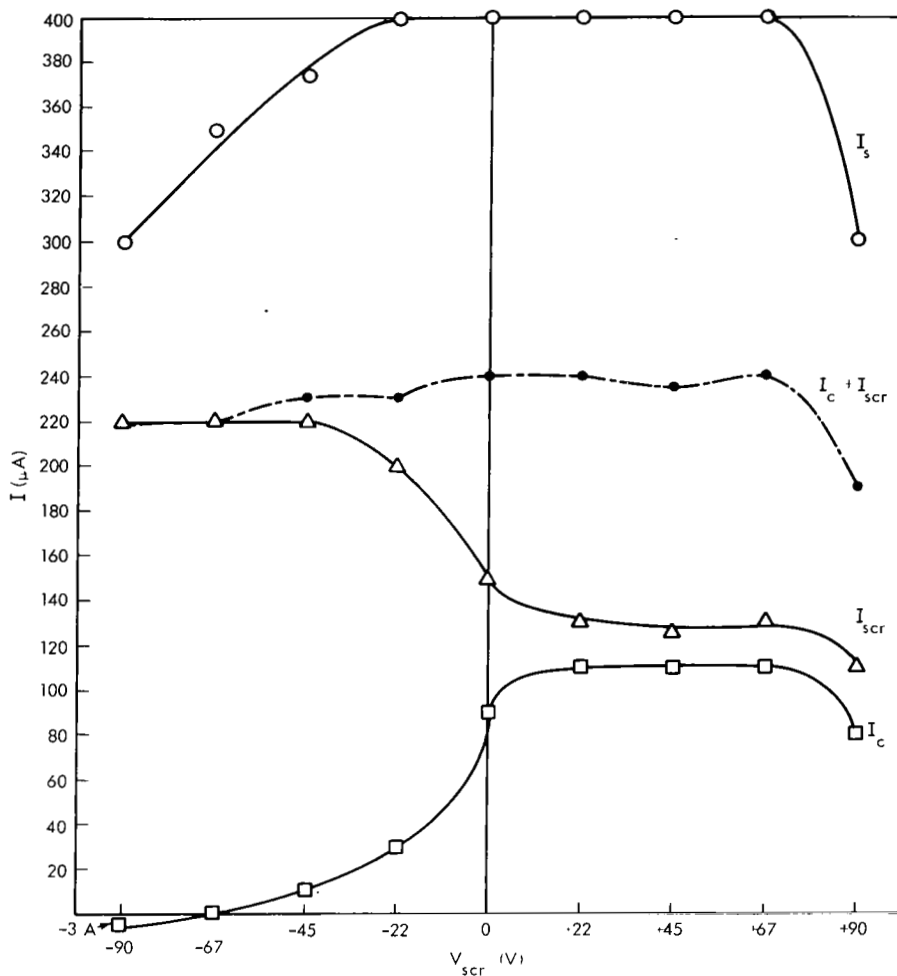
Figure 16—Current variations versus V_{scr} for AS-30 at $V_s = 17.750$ V.

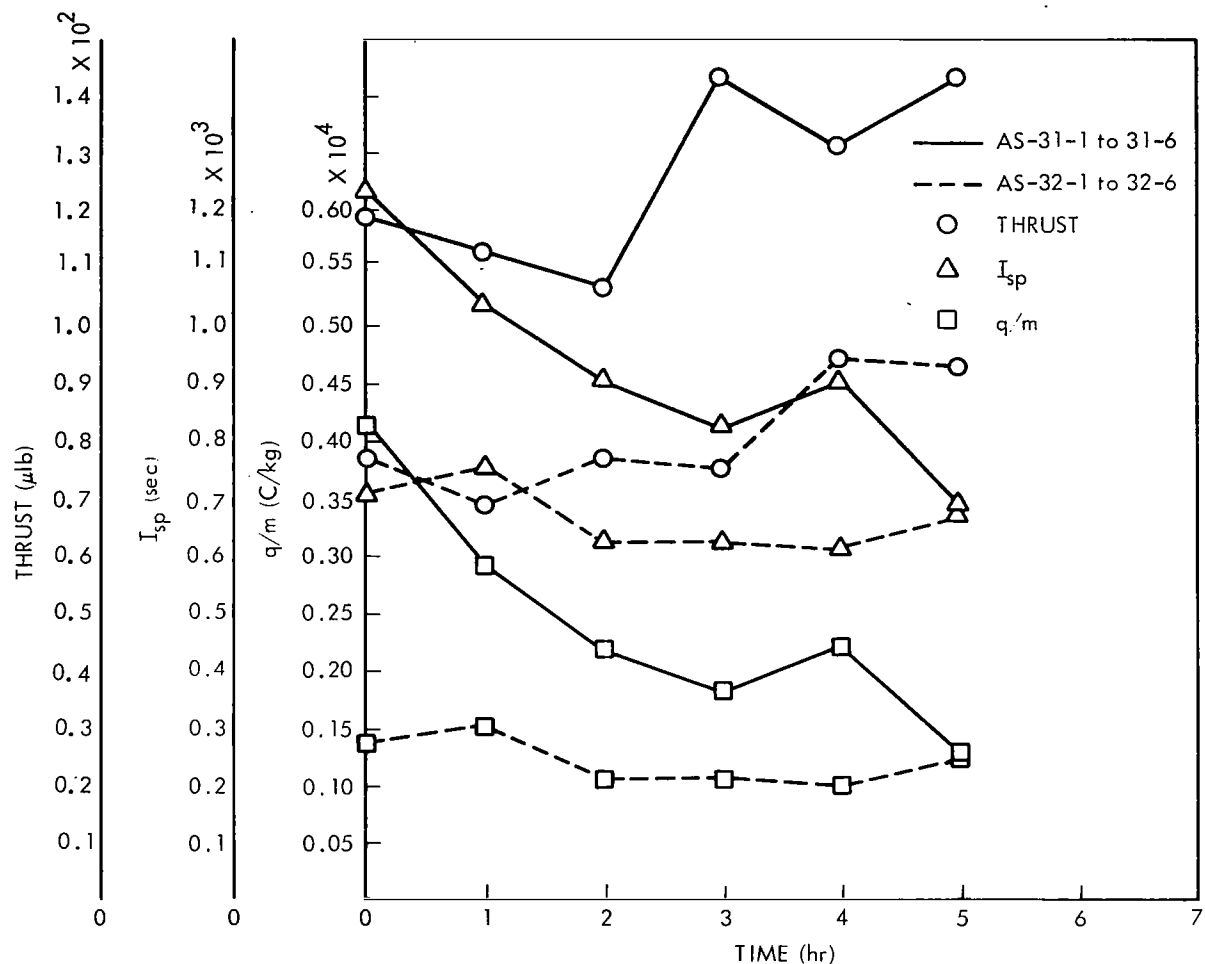
Figure 20—Performance curves versus time. $V_s = 18$ kV, $V_{ext} = -2$ kV, $V_{scr} = +45$ V, and propellant No. 20 was used.

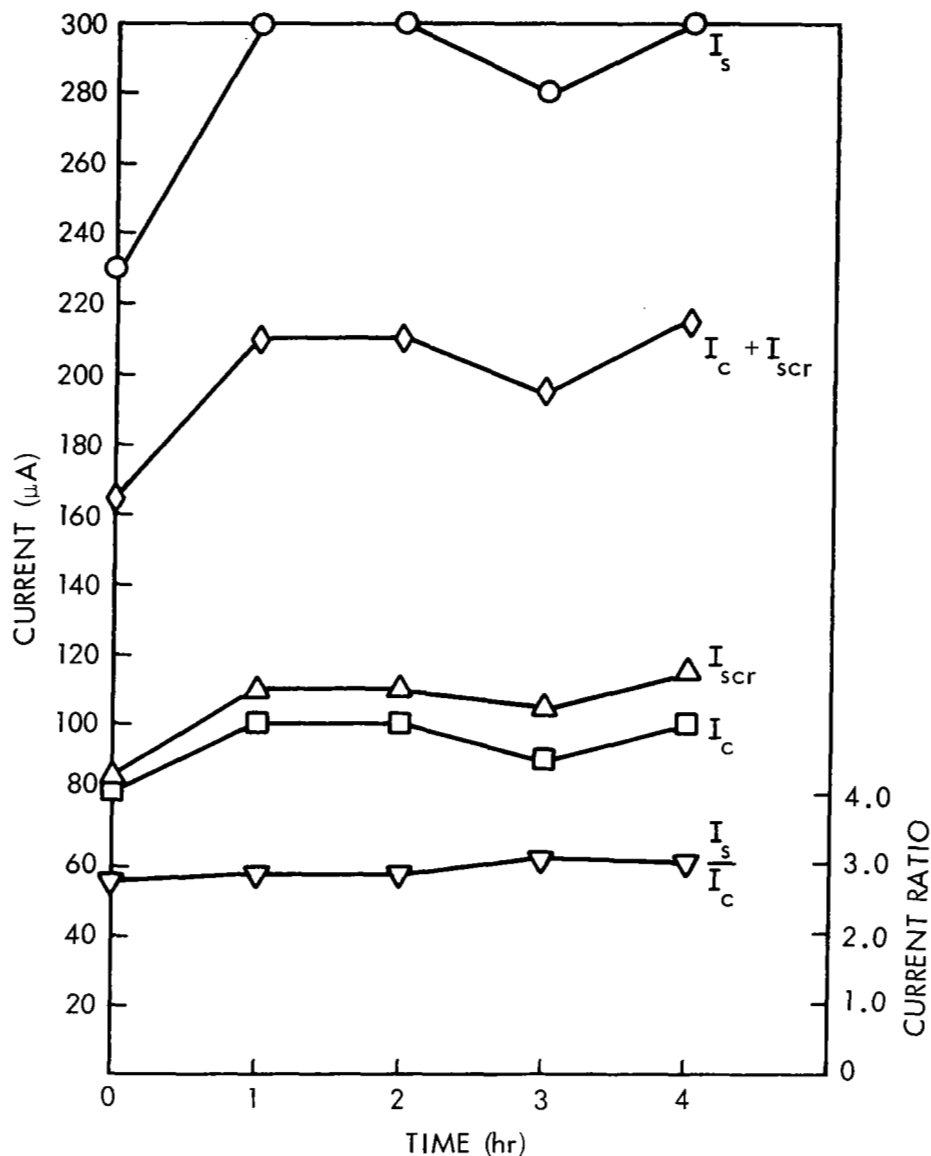
Figure 21—Current versus time for AS-33-1 to 33-5.

As can be seen from Figure 21, the ratio of source to collector currents is slightly less than 3 during this time, which indicates good focusing. The performance during this time is shown in Figure 22 and is relatively stable. Data from the V_s variation test points are plotted in Figures 23 and 24. An interesting relationship between V_s , I_s , and $I_C + I_{scr}$ is shown in Figure 23. As V_s is increased, I_s and $I_C + I_{scr}$ rise almost linearly; however, when compared to the performance curves in Figure 24, the only effect appears to be an increased flow rate, which resulted in increased thrust. Another important result of the V_s variation shows that the ratio I_s/I_C remained fairly constant, again an indication of good focusing. Test point 33-14 was operated at a feed pressure of 135 mm Hg resulting in a flow rate of 4.65×10^{-7} lb/sec. The resulting I_{sp} and q/m at this point were reduced to 496 sec and 663 C/kg, respectively, indicating that flow rate control has a greater effect on performance than V_s control.

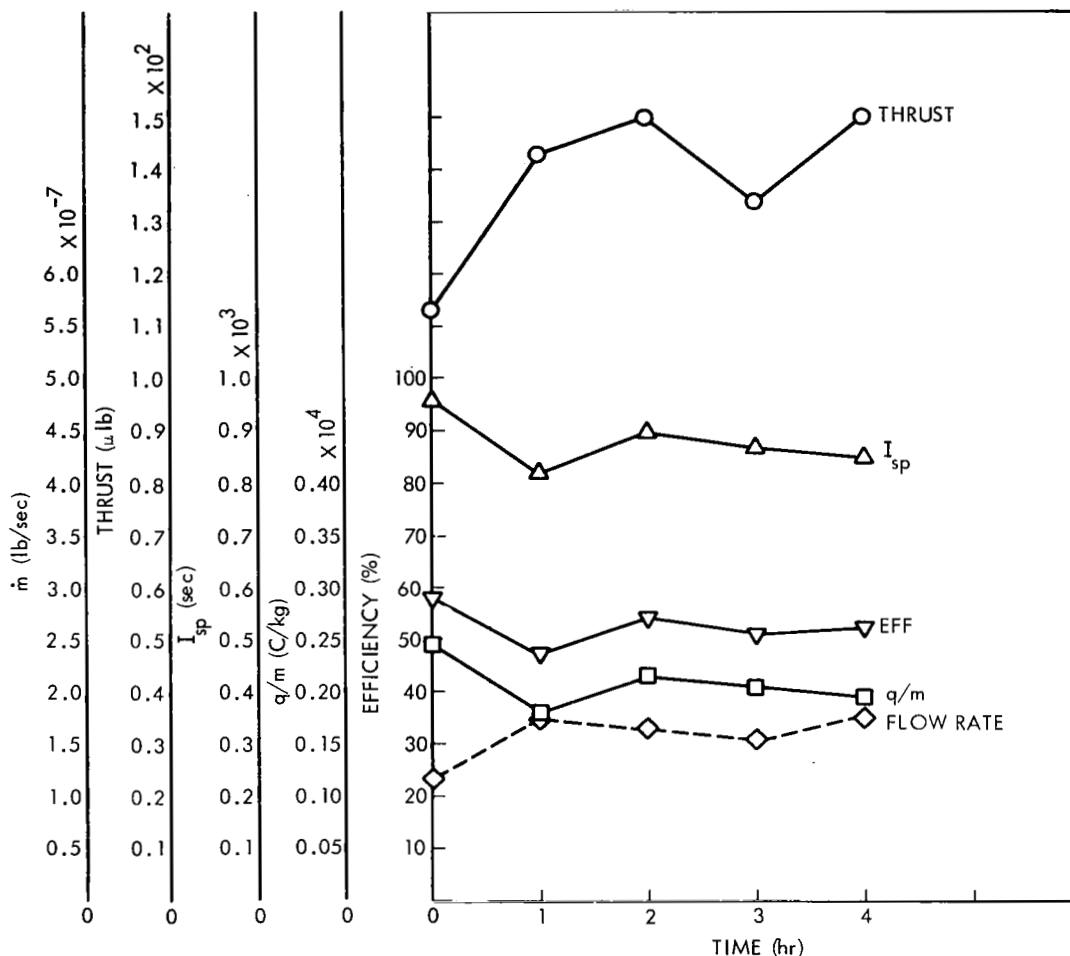
Figure 22--Performance curves for AS-33-1 to 33-5. $V_s = 18$ kV, $V_{ext} = -2$ kV, $V_{scr} = +45$ V, propellant No. 20 was used, and $P_f = 60$ mm Hg.

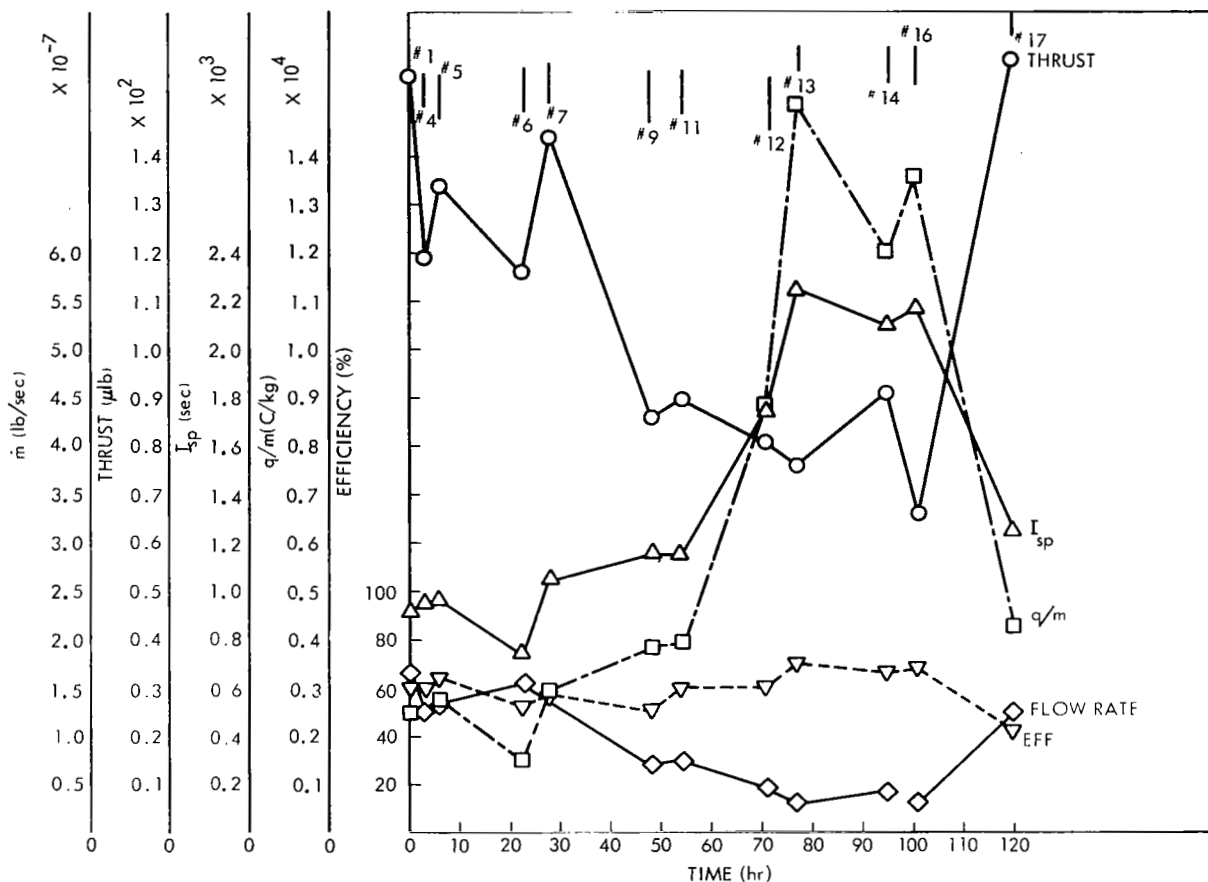
Figure 26—Performance curves for AS-35. $V_s = 15.75$ to 18 kV, $V_{ext} = -2$ kV, $V_{scr} = +45$ V, propellant No. 21 was used, and $P_f = 60$ mm Hg.

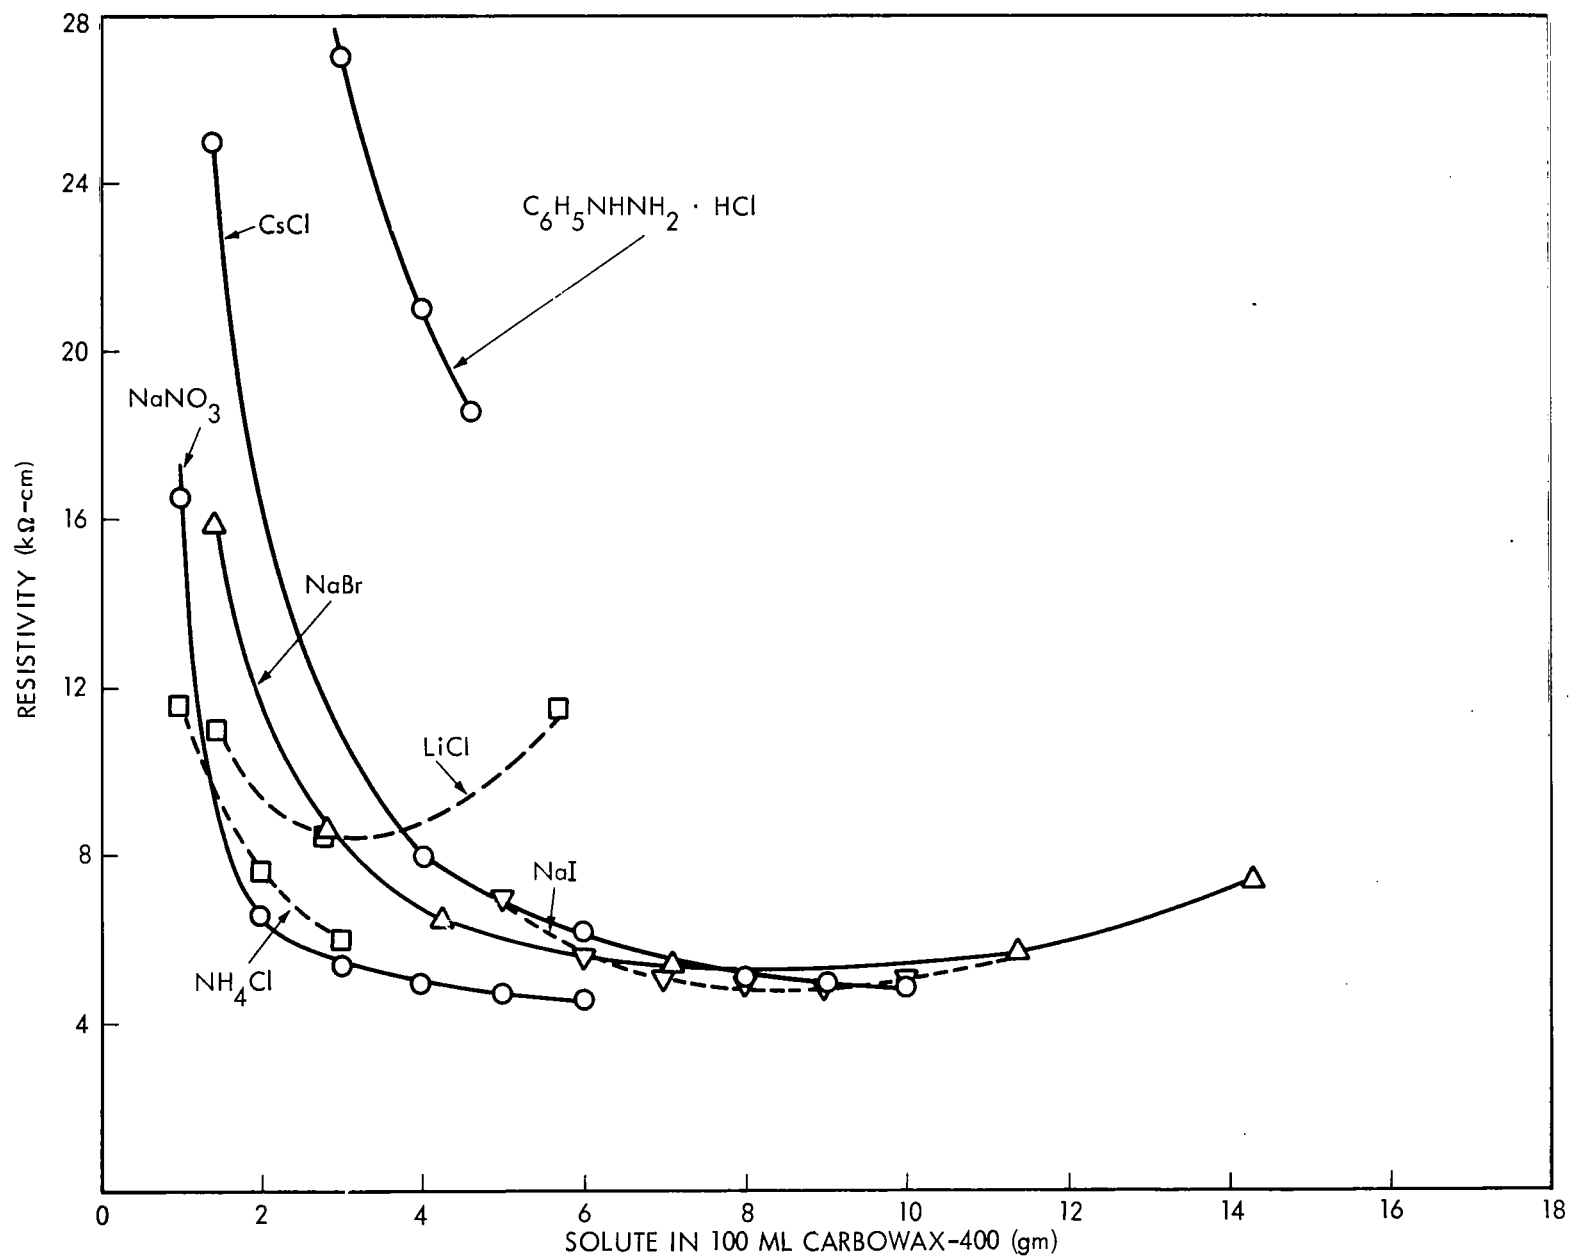
Figure 33—Solution resistivity of solutes dissolved in 100 ml of Carbowax-400.

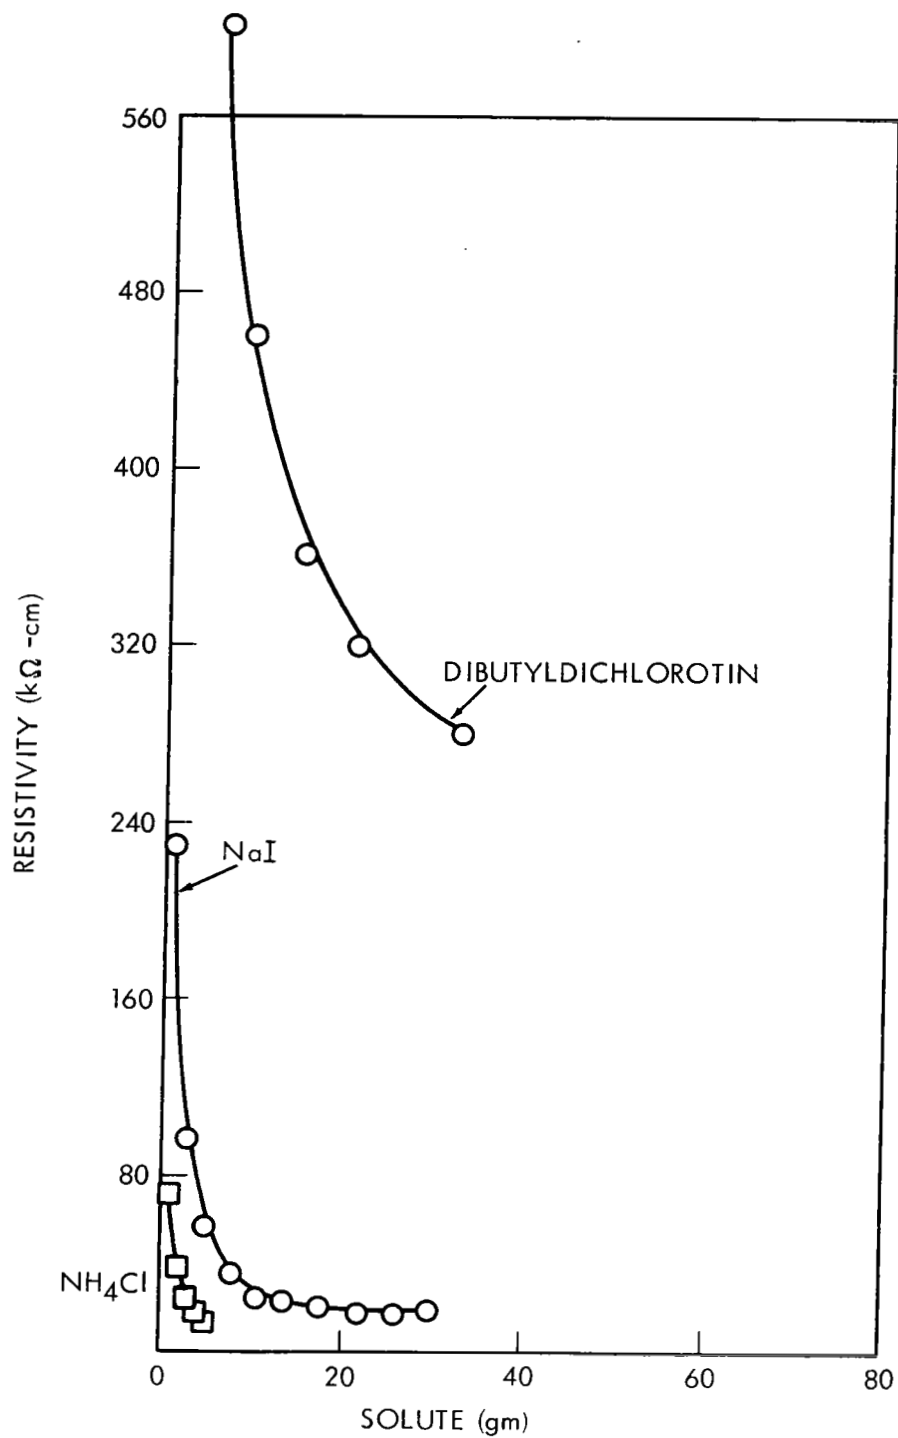
Figure 34—Solution resistivity of solutes dissolved in 100 ml of 1, 2, 6-hexanetriol.
